The Suction side of a pump is not the only part of a pump that can be damaged by cavitation and recirculation. Discharge cavitation damage is less prevalent, but its effects can be equally damaging.

Dale B. Andrews

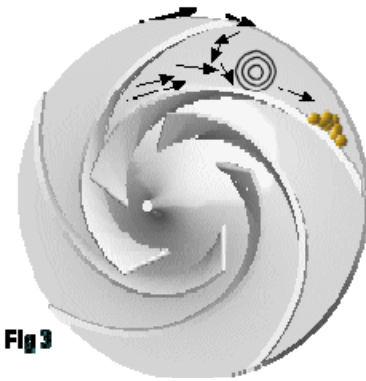
Fig 3

Discharge recirculation occurs when high pressure flow streams re-enter the impeller on the low pressure side of the impeller vane. This is caused by the pump operating back on its curve or with an inlet restriction. The reverse flow within the impeller passage shears across the outgoing flow, sets up vortices along the pressure wall of the impeller, and causes cavitation along the pressure wall and shrouds adjacent to the impeller outlet.

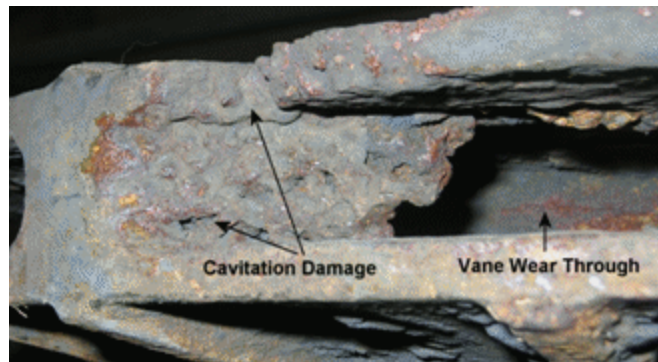
The photograph below is of an impeller from a pump recently returned for repair. The cavitation craters are evident at the pressure side blade tips and the adjacent shroud. Each vane has worn through on the pressure side along a section extending between 70% and 85% of the impeller diameter. The impeller was in a slurry service and the large holes in the vanes are most likely accelerated wear due to the internal turbulence. Note the almost pristine condition of the vane trailing edge at the far left of the photograph. Normal wear for a slurry pump impeller would be the evolution of knife-edge shrouds and blade tips, with the blades eroding back from the blade tips back toward the impeller eye.

Pumps operating off-design for extended periods are subject to increased operating costs and mechanical failure. The conditions that a pump is designed for are not necessarily the same operating conditions it will be exposed to 10-15 years later. A re-rate of an impeller can be worthwhile on large equipment and should be considered as a part of equipment life cycle cost management.
