In this 6th installment of The Seven Deadly Sins of Pump Ownership¹ we present the first of a two-part series on misalignment. Misalignment is a common cause of premature pump failure. Causes of misalignment may be static or dynamic in origin. Static misalignment is defined as misalignment that is measurable when the equipment is not in operation. Dynamic misalignment is defined as misalignment that is detectable only during operation. In this issue we will discuss sources of static misalignment and corrective actions that can be taken to improve pump reliability. Static misalignment can be caused by parts that are out of tolerance, static shaft deflection, coupling misalignment, and improper pump installation.

Static Shaft Deflection

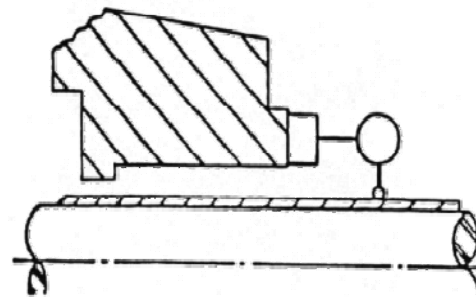
A bent shaft is easy to detect and difficult to repair. To determine if a shaft is bent at the seal housing, mount a dial indicator on a stationary surface, such as the seal housing, and measure the runout on the shaft sleeve while turning the shaft through 360 degrees. Total Indicated Runout (TIR) of more than 0.002 in (0.05 mm) warrants a repair or replacement of the pump shaft.

Shaft Sleeve Runout

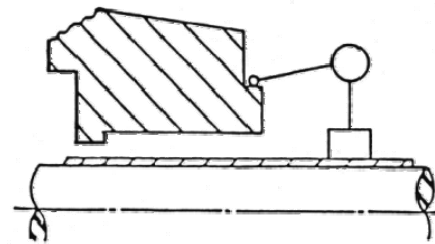
Misalignment that is indicated by a lack of concentricity or parallelism may be measured by mounting a dial indicator on the shaft sleeve. While rotating the shaft and dial indicator, measure runout on the seal housing bore or register for concentricity and at the seal housing face for parallelism (angularity).

Seal-Chamber Register Concentricity

If the seal housing concentric runout is greater than 0.005 in (0.127 mm), or the face runout is greater than 0.0005 in/in of seal housing bore diameter, further investigation and corrective action is warranted. Potential causes of an out of tolerance seal housing runout reading include excessive static shaft deflection, out of tolerance assemblies and deformation of the pump assembly due to high structural loads.

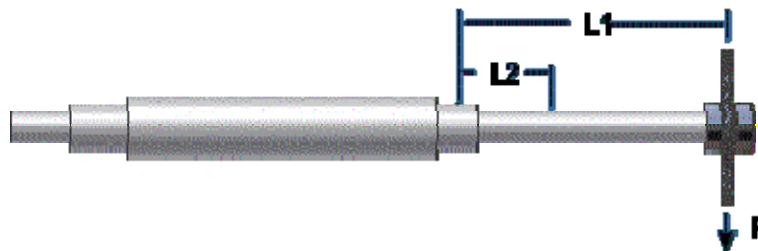
Although it is unusual for static deflection by itself to be a problem, calculating the static deflection at the seal housing provides an indication of how much of the total deflection is from the overhung load and how much is from other causes. A single stage overhung shaft can be treated like a cantilevered beam. The impeller creates a radial downward force, “F”, at some distance, “L”, from the nearest support bearing. The deflection can be calculated by the equation

Where:

y_C = Shaft deflection at the Impeller centerline

F = Weight of the Impeller

L1 = Overhang from the closest bearing

E = Modulus of Elasticity for the shaft material

D = Shaft diameter under the sleeve

I = Shaft moment of inertia ($0.049 D^4$)

Deflection at the Seal housing can be approximated by $L2/L1 * y_C$.

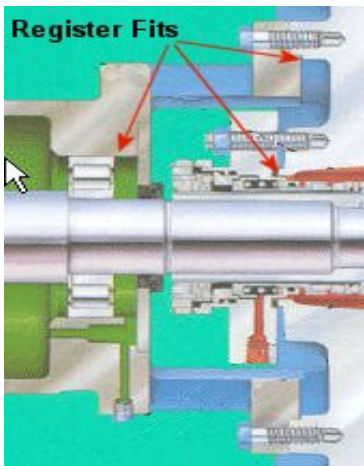
Worn Parts

Misalignment that is due to the tolerances of the assembled machined components is harder to detect. There are usually several register fits between the bearing supports and the seal housing. These fits need to be machined concentric and square. Measurements should be done on a machine. Although an individual register may appear to be out of tolerance by only a small amount, it is important to remember that the total misalignment of the assembled parts will be the sum, or stack up, of the individual component misalignments. Register fits are subject to wear and corrosion over time and should be checked as part of any major maintenance.

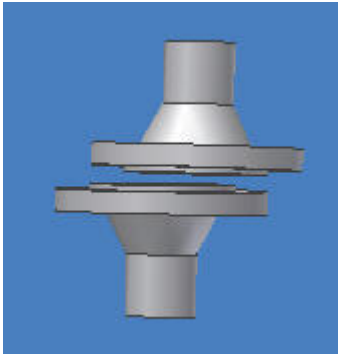
Piping Misalignment

Mating flanges should be concentric and parallel. Bolting of misaligned piping to a pump will cause both the piping and the pump to distort. The amount of distortion is related to the relative size and strength of the pump and piping, as well the distance from the nearest fixed hold down. Pump manufacturers provide allowable nozzle loads by request, or as part of their standard documentation. If mechanical leverage is required to bring the flanges into position then the nozzle loads should be checked.

If the piping connections are suspect for reliability problems, mount a dial indicator so as to check for shaft alignment at the seal housing as described for checking shaft angularity and parallelism. If connecting or disconnecting the piping changes the shaft alignment, then corrective action should be taken. This sometimes requires cutting and field welding to obtain proper nozzle alignment.
