Improve FCCU Profitability - Bottoms System Upgrades

A review of process flow scheme fundamentals and basic equipment operating and design principles that have improved unit operating profitability through better use of capacity, higher conversion and lower cost maintenance

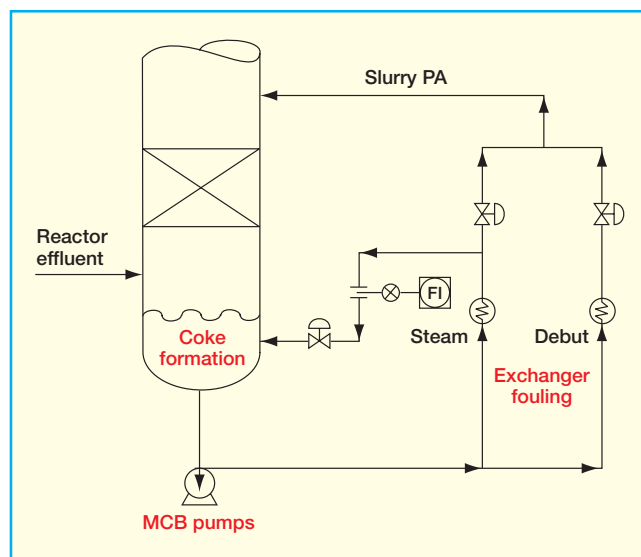
Figure 1. MCB System and Problem Areas

Superheated vapor enters the main column at 930-1025°F (500-550°C) where it contacts a portion of the main column bottoms stream. The MCB system removes heat from and scrubs catalyst fines from the reactor effluent stream. Consequently, the system operates at high temperature

and contains solids that can erode and plug equipment not specifically designed for such difficult conditions (Figure 1).

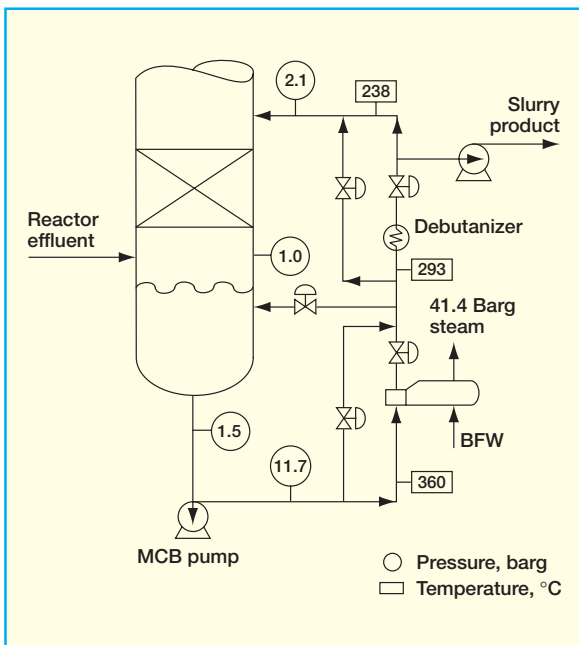
Figure 3. MCB Series Heat Exchanger Configuration

ly in series (Figure 3). Using exchangers configured all in parallel reduces system pressure drop and lowers pump capital and operating costs. It has the disadvantage of high MCB temperature – approximately 680-700°F (360-370°C) – when employed for Debutanizer reboiler heat. In this service minimizing tube wall temperature is essential to control shell-side fouling. Series-piped exchangers lower the MCB temperature to 560°F (293°C) for reboiler service but raises system pressure drop, increases pump head, pump speed, and rate of pump erosion from particulates. MCB equipment design and selec-

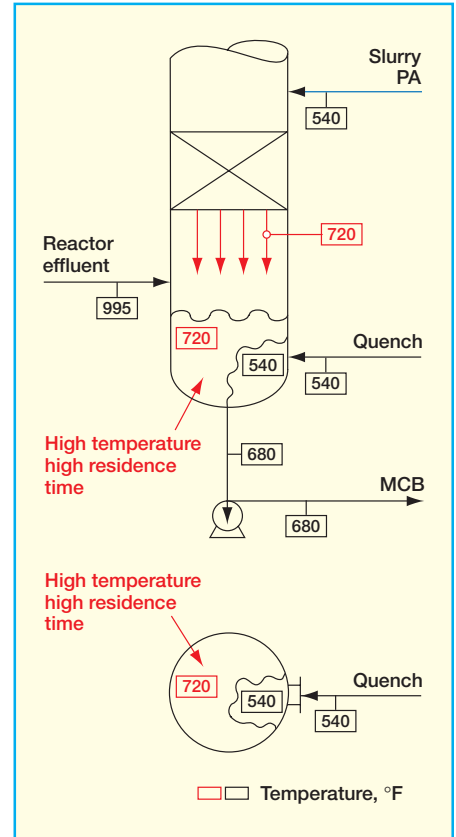
Figure 4. Poor Quench Distribution

Typically, the unquenched liquid leaving the column internals and the quench are not thoroughly mixed, causing localized MCB pool temperatures equal to the unquenched stream leaving the column internals (Figure 4). Quench must be evenly distributed to suppress formation of the fouling material. Because main fractionators are 12-28 feet (3.6-8.5 meters) in diameter, an improper design will not ensure that the quench is distributed across the column cross-sectional area. Localized bottom temperature can thus be as high as the unquenched temperature of 750°F (400°C), resulting in rapid exchanger fouling and coke accumulation in the bottom of the main column.

Both localized MCB liquid pool operating temperature and residence time contribute to fouling, the former being the main factor. Because most refiners measure bottom temperature in the suction line to the MCB pump, they incorrectly assume that it reflects MCB liquid pool temperature. This is only true if the quench is uniformly distributed across

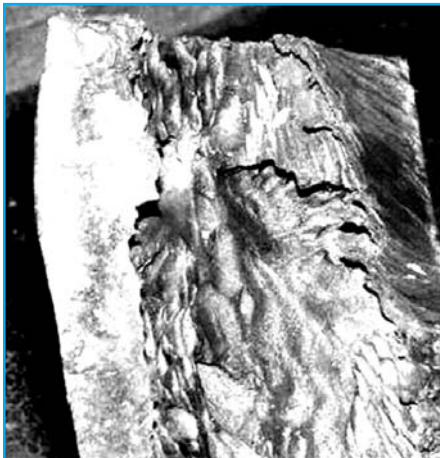
Photo 2. Erosion of Standard API 610 Pump

Reliability of the Standard API 610 process pumps handling MCB bottoms has always been a problem due to their susceptibility to internal erosive wear (Photo 2).

In the extreme cases, erosion caused by coke and catalyst particles can erode the pressure-containing casing itself. API pump manufacturers and refiners have had only limited success in trying to improve the wear resistances of the ductile pressure-containing casings through the use of thermal spray coatings, diffusion alloy coatings, weld overlays, and hard metal wear plates. At high temperatures thermal spray coating have a tendency to crack and chip off as shown in Photo 3, leaving substrate material open to corrosion and abrasive attack.

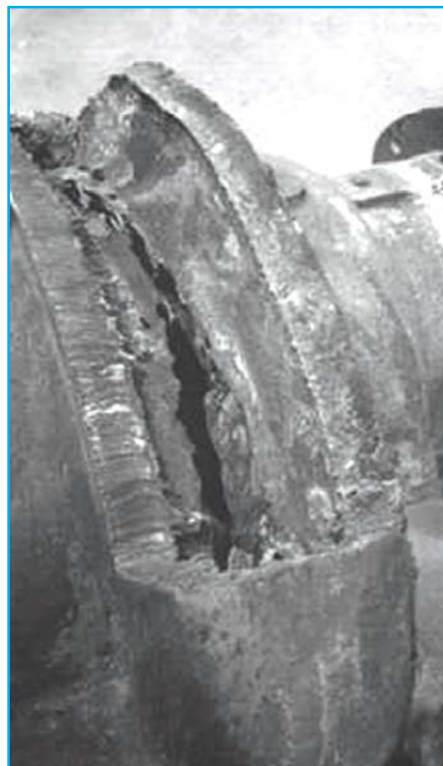
Photo 4. Casing Failure

If re-machining is needed to remove the distortion that happens to the base material during welding and subsequent heat treatment, costs will approach that of a new component. Hard metal wear plates are sometimes used to form a Partially Lined Slurry (PLS) Pump. The 25 % chrome iron liners protecting the casing walls work well. However, the coated pres-

sure containing volute section of the casing can be eroded away as shown in Photo 4.

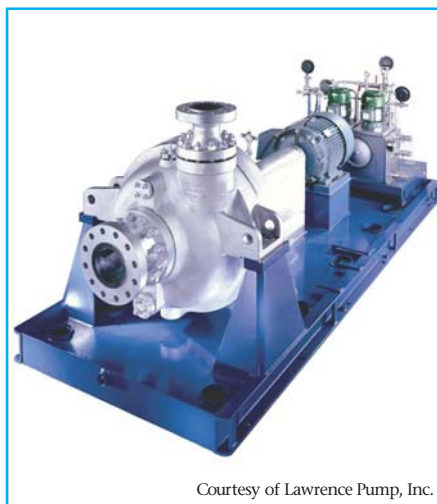
Photo 5. Fully Lined API Pump

The API fully lined pump design allows the wear resistant 25 % chrome iron liner material to be used in the high velocity areas to resist the erosive attack of the catalyst and coke particles. The liners offer 4-6 times the wear life of a coated part. They can be re-machined to remove worn surfaces, replaced if worn out or upgraded for additional life. The softer ductile pressure-containing casing material is fully protected from the high velocity slurry.

years, MCB system reliability is critical. Important considerations are quench system design, high exchanger velocity from start-of-run, exchangers in series when MCB is used for debutanizer heat, and the use of API fully-lined pumps to maintain their flow-head characteristics throughout the duration of the run (Photo 5).

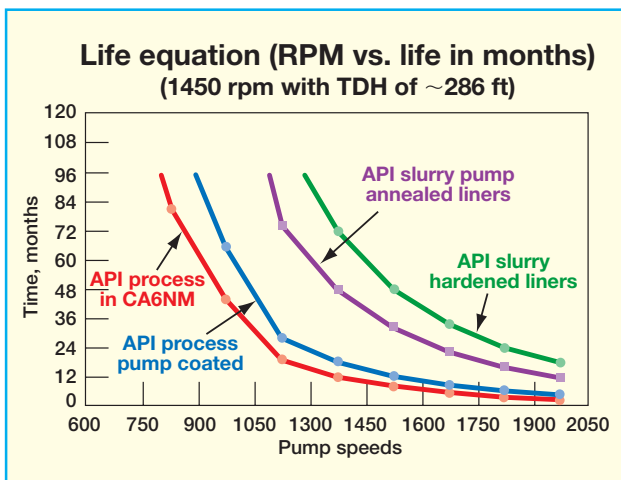
Figure 9. Pump Operating Life

head, larger diameter impellers allow pumps to run at lower speeds. The chart on Figure 9 shows that for a pump speed of 1450 rpm and a total dynamic head of 286 feet, the operating life of a standard API process pump will be approximately 12 months. There is an exponential increase in wear as the speed increases. An API fully-lined slurry pump with 350 BHN liners running at the same conditions, however, will provide an operating life of 4 years.

If the liners and impeller are hardened, pump operating life will increase to 6 years, therefore, a fully-lined API 610 slurry pump in MCB service can be operated continuously between schedule unit shut-downs.

Examination of Equation 3 will clarify why API fully lined slurry pumps offer improved operating reliability. Speed plays a critical part in determining pump life, as wear increases with the square of the speed. To develop the same total dynamic
